## Appendix 1

### Comments on (LWP 2006) Addendum to the Environmental Statement

by  
Richard Lindsay  
Head of Wildlife Conservation  
University of East London  
Romford Road  
London  
E15 4LZ

January 2007

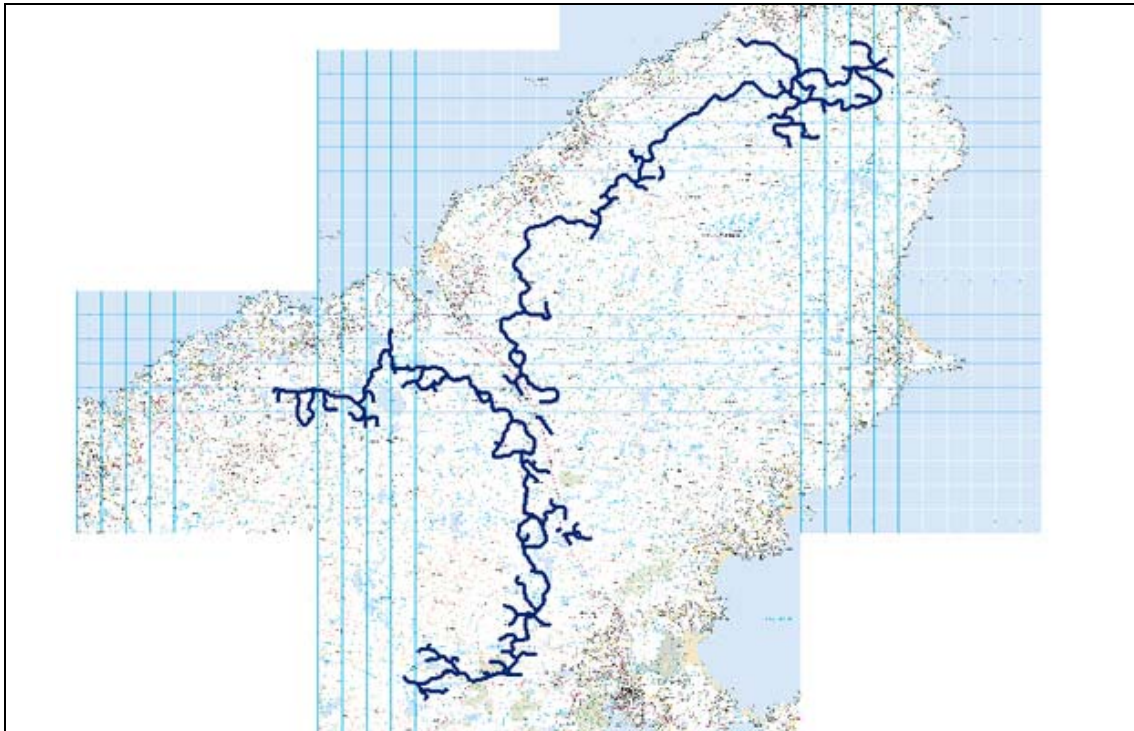
**Figure 1.** Map of the new site-roads for the revised Lewis wind farm proposal.

- 2.3 The development follows essentially the same routes as before (see Figure 1), albeit over a reduced total area (see Figure 2), with the result that ‘floating roads’ are still proposed for some 70% of the total road length. This is an enormous proportion of road infrastructure to be using for a construction technique that is relatively untested. Indeed not only is evidence available to show that such roads do not behave as predicted by the developers, but the construction technique described in the ES makes no reference to normal engineering practice on such soils, as will be discussed later.

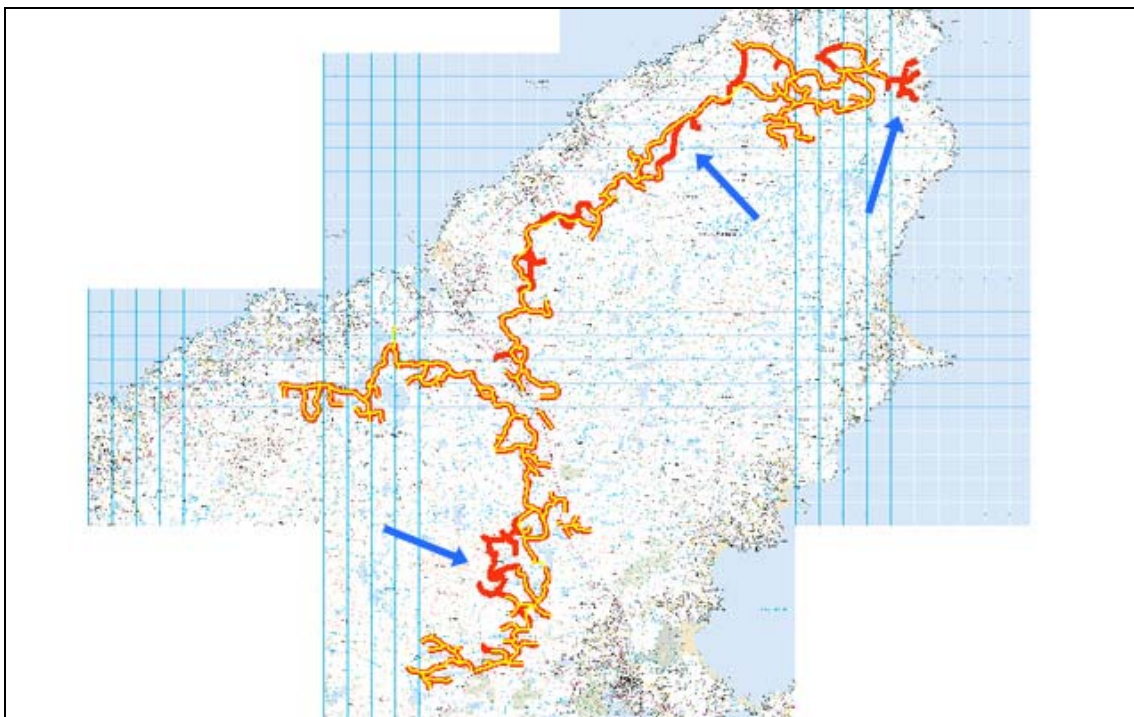
**Figure 2.** The new proposed site-roads (yellow) displayed over the route of the original development proposal (red). Blue arrows highlight significant areas of originally proposed site-road layout that are no longer required for the revised development proposal.

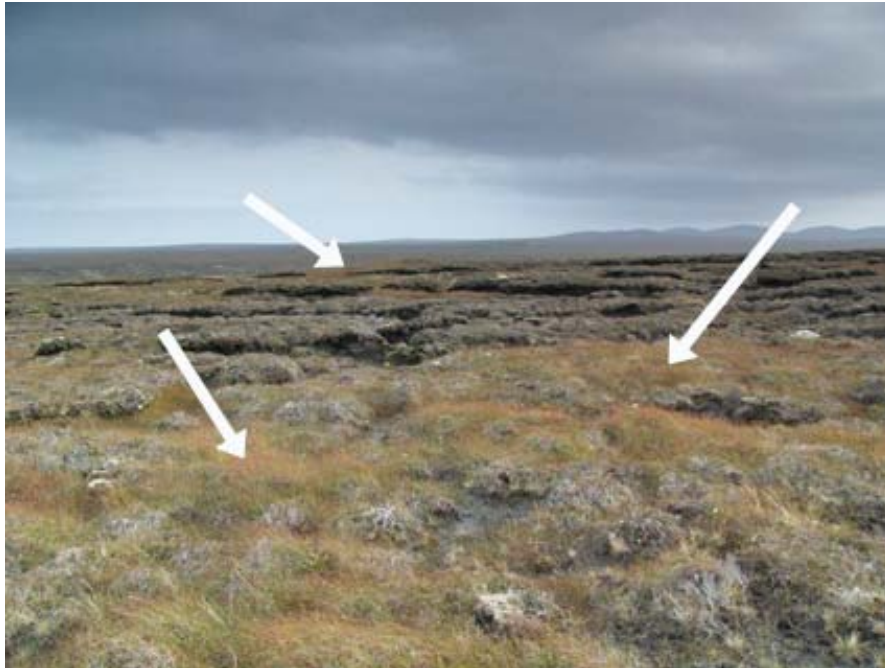
**Figure 3.** Area indicated by LWP (2004) ES as NVC type H10b (dry heath). Arrows point to the abundance of common cotton grass (*Eriophorum angustifolium*) – a defining species for bog, rather than heath, communities - within the hagg-top vegetation.

- 4.5 A closer look at the species composition of hagg tops in the erosion complexes of Lewis reveals why it is appropriate to continue to classify the vegetation as still essentially a mire community, albeit a species-poor example where there has been severe erosion. Figure 3 shows an area defined in the LWP (2004) ES as heavily eroded H10b dry heath. It can be seen from Figure 3 that the ground is indeed eroded blanket bog, but also that there is a substantial proportion of common cotton grass (*Eriophorum angustifolium*) within the vegetation, providing a characteristic chestnut tint.

- 4.6 Common cotton grass is one of the key species differentiating bog peat systems from other habitat types. Dry heath is characterised by the absence of cotton grass (see Rodwell 1991). The extent of cotton grass in Figure 3 makes it quite clear that, even on most of the hagg tops, the vegetation is still essentially a mire (peatland) vegetation rather than a heath community. Widespread use of H10b on deep peat, as used by the mapping process of the LWP (2004) ES, would therefore still seem to be unjustified and inappropriate despite the extra justification put forward by the LWP (2006) Addendum. The assignment of blanket bog habitat to a dry heath vegetation type does not fit with the nature of the species assemblage, and distorts the

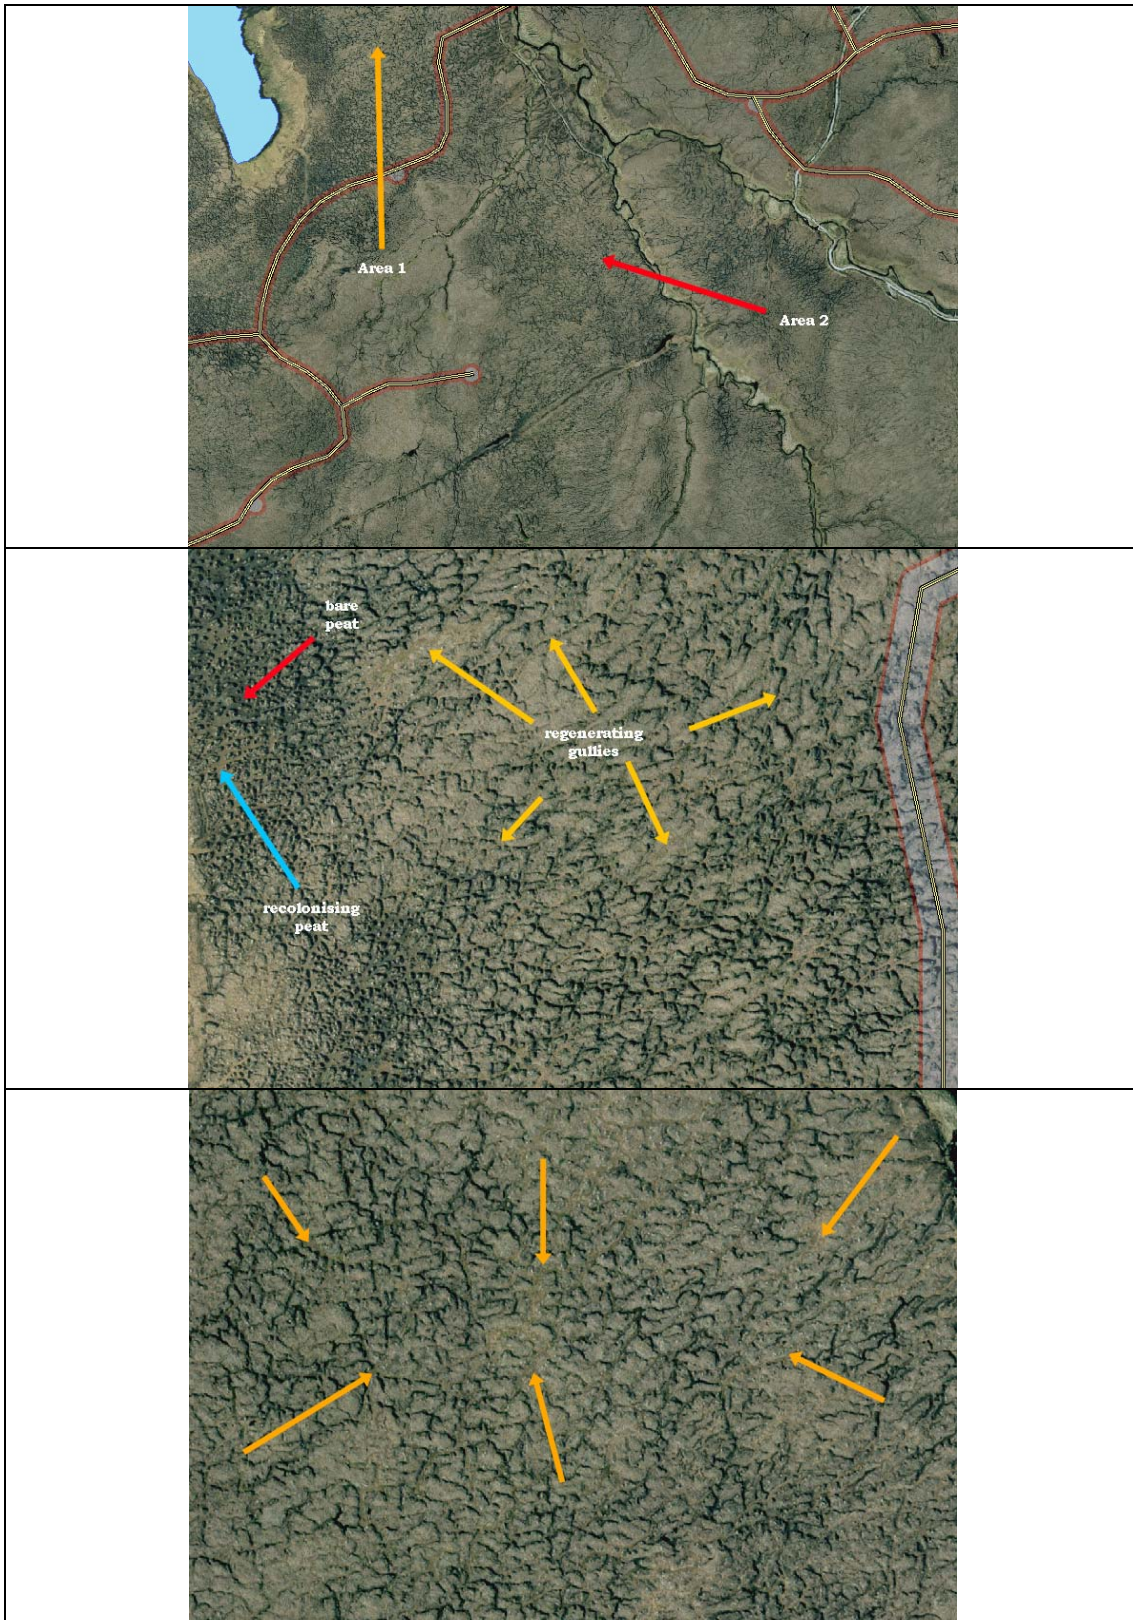
**Figure 4 (a, b, c)** (a) A typical area of peat erosion within the Lewis Peatlands SPA. Arrows indicate the two areas for which more detailed views are provided. (b) Area 1 detail, with orange arrows showing re-vegetated gullies, a blue arrow indicating re-vegetating sheet erosion, and red for bare peat erosion. (c) Area 2, with orange arrows highlighting some of the many re-vegetated erosion gullies.

- 5.3 The scale of recovery can perhaps best be appreciated with reference to colour aerial photographs (see Figure 4), where the pale chestnut of cotton grass and paler shades of *Sphagnum* can be seen to dominate the network of erosion gullies.

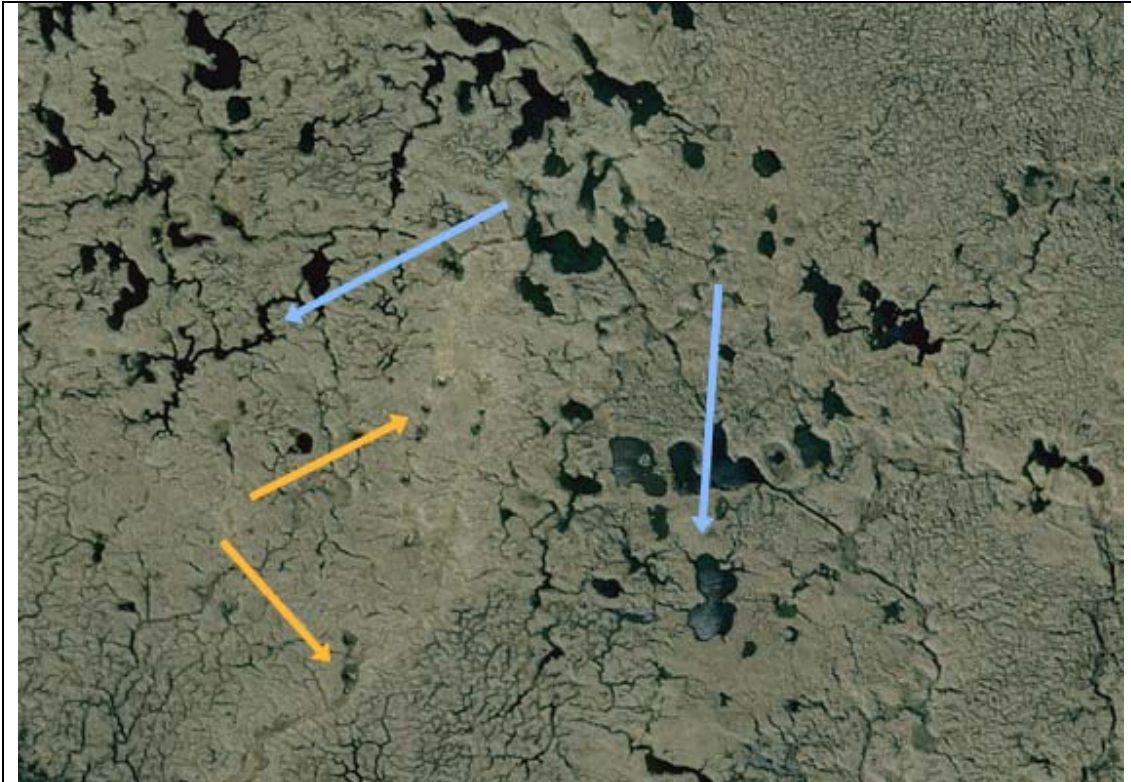
**Figure 5.** Line of sink holes (and thus presumed peat pipe) within pool system at NB4355. This same system is illustrated in Plate 11B.24 in the LWP (2004)ES. Note the relatively smooth ground associated with the sink holes (orange arrows), and the high water table in the pools arrowed blue on the right. Blue arrows point to water-filled pools evident in Plate 11B.24 of the LWP (2004) ES.

- 6.7 Indeed Figure 5 shows the same site as Plate 11B.24 of the LWP (2004) ES (referred to again in the LWP 2006 Addendum). In that document it is captioned as illustrating “Collapsed subterranean pipes as shallow depression lines and circular hollows, probably draining extensive watershed pool system (NB4255)”. It is actually located at NB4355, but what is evident even in Plate 11B.24 (and Figure 5) is that many of the large pools have high water levels – despite the immediate presence of this large peat pipe.

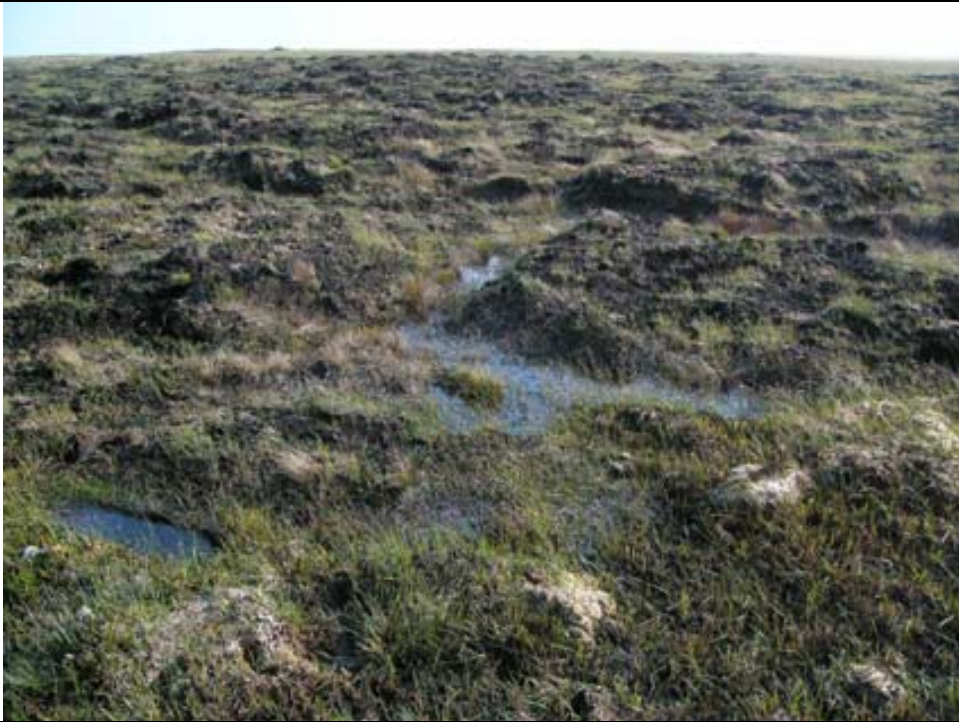
**Figure 9.** Blanket bog damaged by very recent fire within the SAC. Photo taken in November 2006.

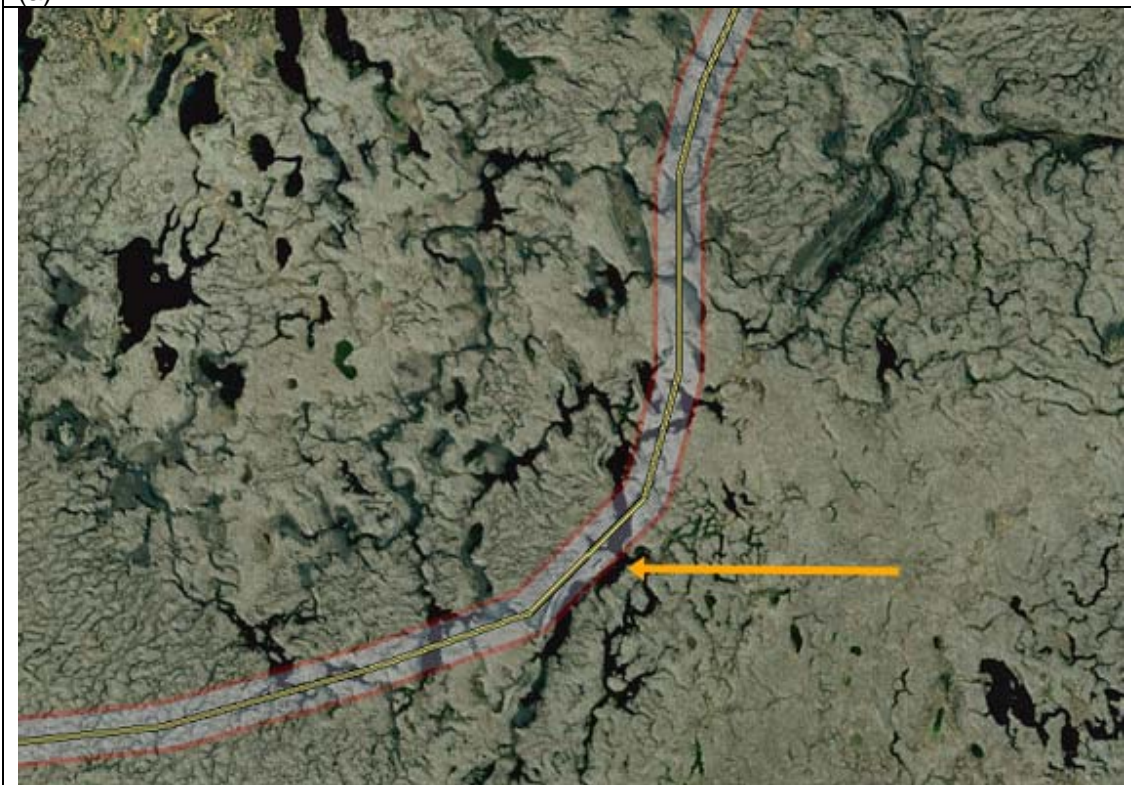
**Figure 10.** Two overlapping scenes from part of the proposed site roads located to the north of Turbine G36. Major pools that cross the track of the proposed road are arrowed orange. Note also the pale brown colour of the erosion gullies downslope (to the upper right) of the road; these are re-vegetating vigorously with peat-forming communities (i.e. this is 'active' blanket bog).

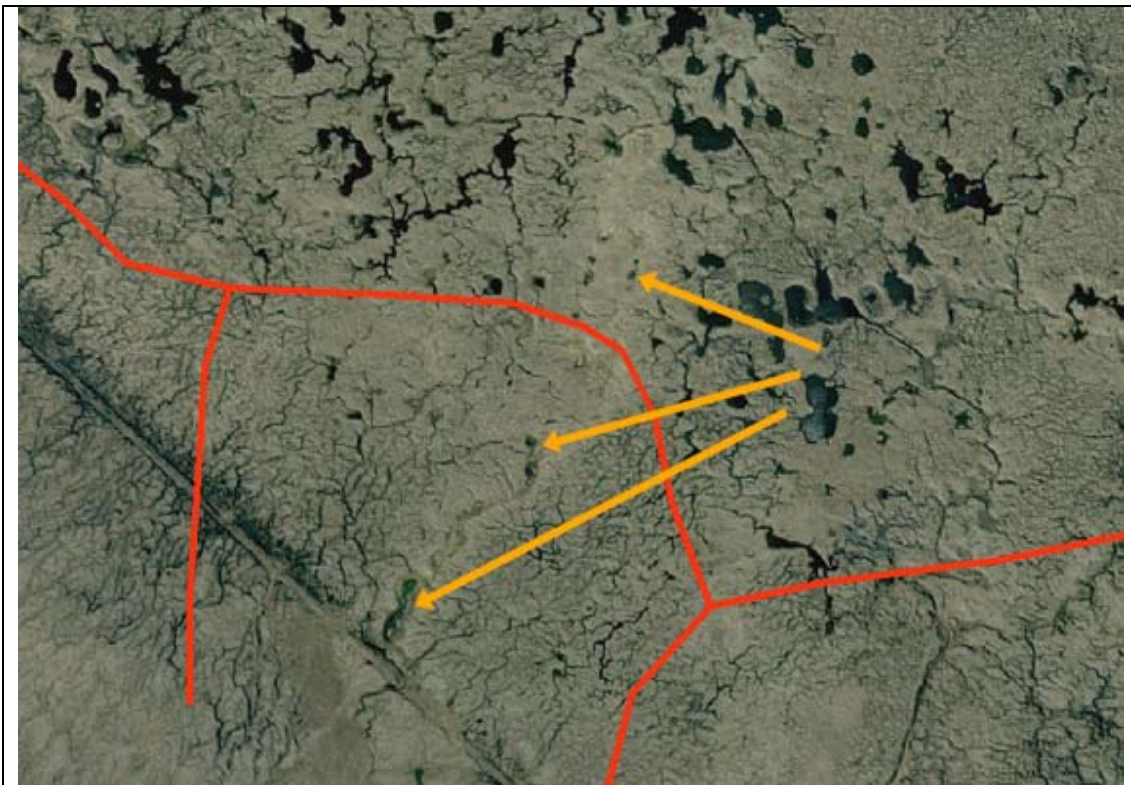
**Figure 11.** Line of proposed road (in red) close to Turbines G40 and G42. The road crosses an obvious line of sink holes (arrowed orange) and thus may compromise the associated peat pipe. The distance upslope (to top right) along the line of sink holes from the road to the large pools is 150m.

- 10.4 Taking another example of potentially complex impact interactions, Figure 11 shows a section of road near Turbines G40 and G42. The route of the road runs directly across what is obviously a sink hole/peat pipe complex. Where do the potential impacts extend to in this case? If the road is a floating road and progressively sinks (LWP 2006 Addendum, Appendix 11E indicates that this is likely) then what will be the hydrological implication for the peat associated with the length of this sink hole system? This system extends some 100m upslope into the pool system, and for several hundred metres downslope. What would be an appropriate zone of impact to define in this case? The 10m zone proposed by the (2006) Addendum is unlikely to be appropriate in this case.

10.8 In some cases the potential impact boundary for even such obvious impacts may extend for several hundred meters (as in the case of the sink hole system in Figure 11), but in other sections the impact zone may be very narrow. If it is known that, for example, there are sink holes fairly frequently distributed throughout the impacted landscape, or there are areas where extensive erosion complexes are recognised as likely to be *initiated* by the development, then an impact zone map which is tailored to local ground conditions will embrace a very different area compared to the extent identified by a potential impact assessment using a standard uniform width of impact zone throughout. If the uniform width used is very small (e.g. a few metres), the tailored impact zone would almost certainly be very much larger than this, whereas if the uniform distance is very large (e.g. 1 km), then the tailored impact zone might prove to be significantly smaller in total area.

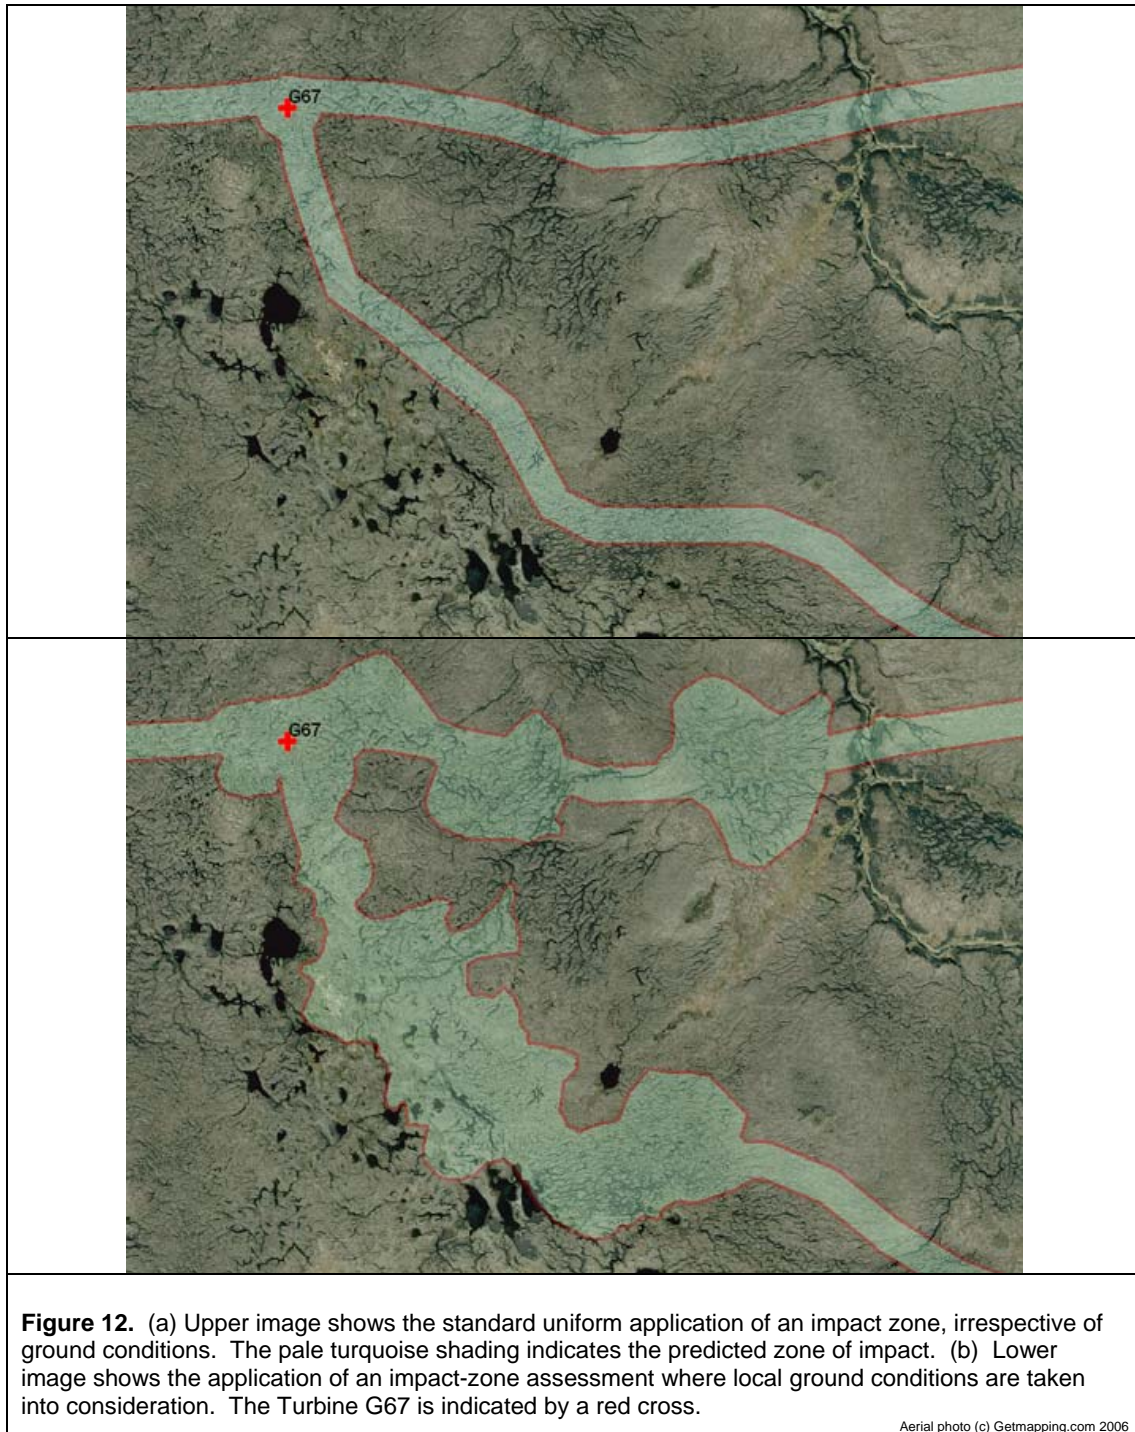
10.6 An example of the way in which the potential impact zone should be tailored to local conditions can be seen in Figure 12. This firstly shows the standard uniform impact zone applied by LWP (2006) Addendum. This uniform approach is then contrasted with an impact zone tailored to local ground conditions. The tailored boundary has been drawn up as an example only, and has thus been created by deciding specifically which areas of the erosion complex are most likely to be obviously and *directly* affected by the presence of the road. If the road passes through a bog pool, for example, it should be reasonable for even the most sceptical observer to accept that the pool will be in some way affected by this. Thus the tailored impact zone restricts itself to only the most obvious effects such as direct breach of a pool or cutting off the water supply to regenerating gullies. The tailored boundary, being only an example, does not attempt to incorporate possible indirect or secondary impacts.

10.7 Thus in Figure 12, a number of features are taken to have some potential for fairly obvious and potentially significant impacts - impacts on which all parties can probably agree: specifically, re-vegetating gullies immediately downslope from the road, pool areas directly affected, flat expanses of wet, regenerating bog vegetation. Elsewhere, on peat that is relatively smooth and gently sloping, the obvious and fairly immediate impacts are assumed to be no more than is suggested by the hydrological studies at Farr Windfarm. It should be fairly obvious that the resulting boundary begins to give a much more realistic

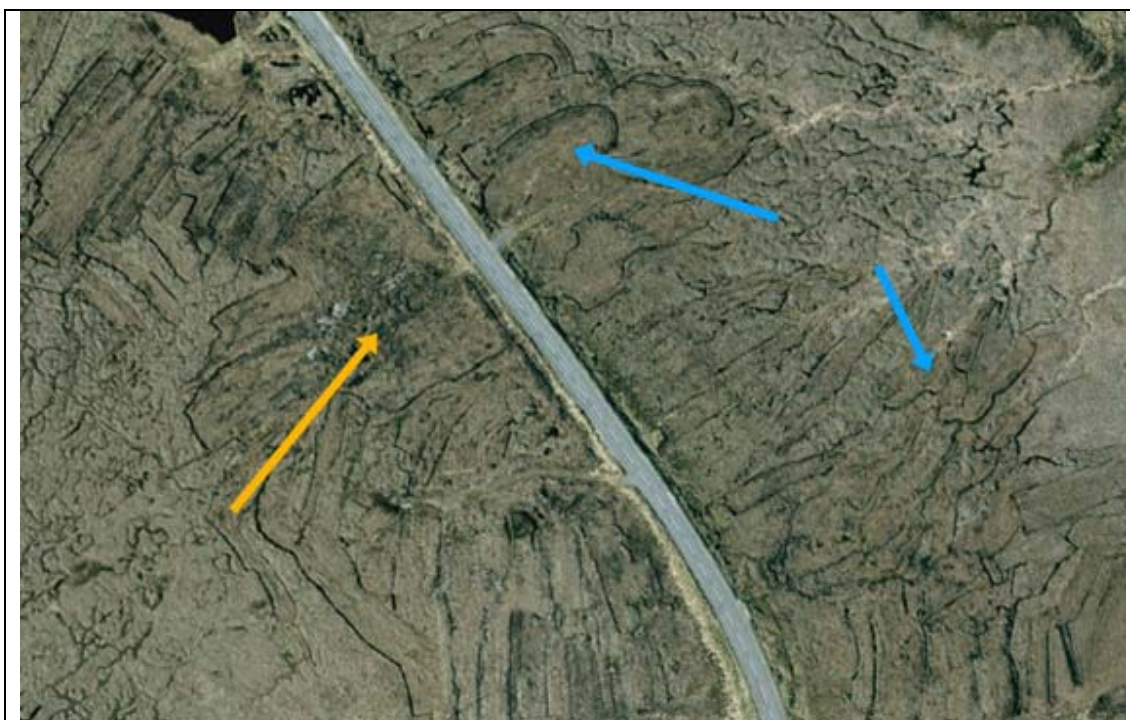
**Figure 13.** Aerial photograph of peat cuttings along the road running north from Stornoway, and identified as suitable locations for restoration proposals involving translocation of peat blocks from the development site to these cuttings. It can be seen that the majority of the cuttings are extremely well vegetated (blue arrows), with only small patches of bare peat (orange arrow).

- 14.3 In fact these old cuttings are generally in an advanced state of regeneration and many support what can be classed as an 'active bog vegetation'. Figure 13 shows part of the area explicitly identified for restoration of peat cuttings. It can be seen from this aerial photograph that virtually all the cuttings are well-vegetated, and field survey has shown that much of this is both *Sphagnum*-rich and supports a wide range of typical blanket bog species.
