Lewis Wind Farm Proposals observations on the official Environmental Impact Statement

May 2005

A Report Commissioned by the Royal Society for the Protection of Birds

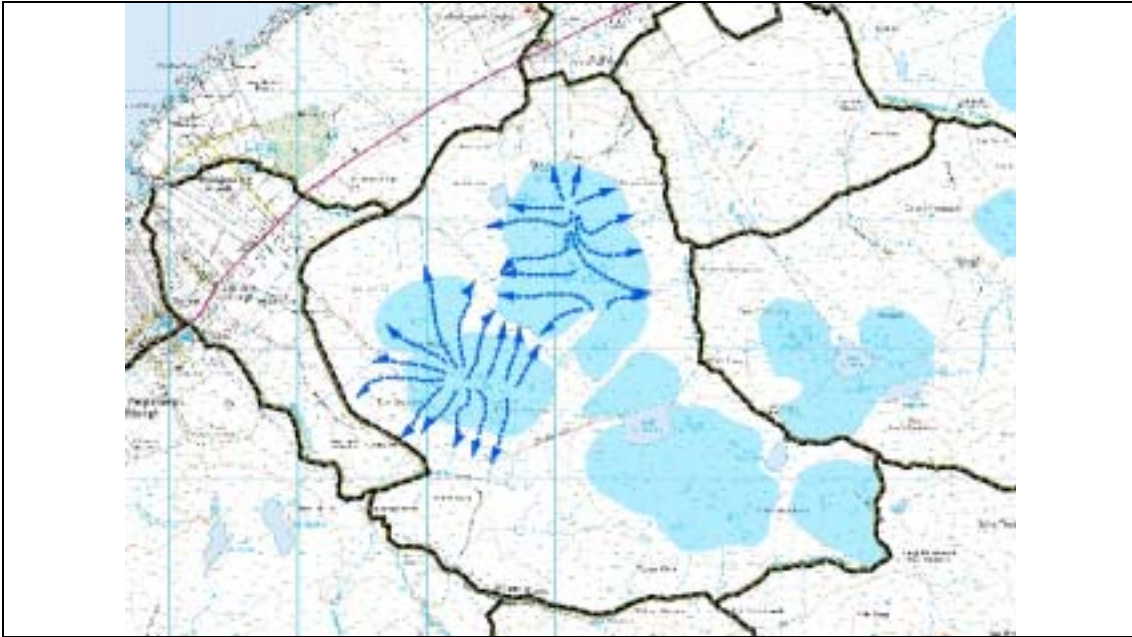
Figure 1. An example of a 'flow net' analysis for part of the blanket mire landscape near Borne, Lewis. Provisional mesotopes are shaded pale blue, and the flow nets for some of these have been drawn (indicated by the dark-blue pecked lines; arrows show the direction of water movement). The boundaries of the composite macrotopes are indicated by heavy pecked black lines. The OS 1:25,000 scale map is provided as background.

Complete evaluation of the various interconnected peatland units within the development area as a whole would involve drawing up flow nets for all areas of ground. Where the flow net either passes directly onto mineral ground, or into a water body that sits directly on mineral ground, this may indicate a section of boundary for a macrotope. However, this is only the case if that section can link directly with other adjacent sections, which can themselves then link to form an enclosed macrotope unit.

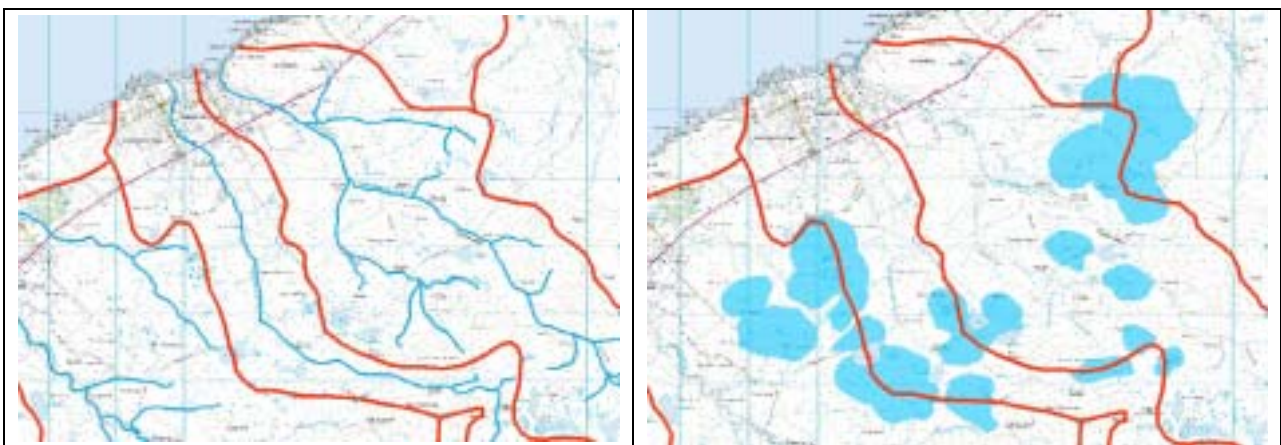
Figure 2. Both maps show part of the Lewis development site, with Ordnance Survey 1:25,000 map information. The map on the left shows main river systems in blue, while the catchment boundaries defined in the Lewis EIS: Fig 6.2 are shown in red. It can be seen that the catchment boundaries cut through several watershed mire systems (as indicated by the mass of small blue bog pools on the OS map). The map on the right again shows the catchment boundaries in red. In addition, however, it shows the approximate extent of several peat bog mesotopes (in mid-blue shading). From this it is evident that a catchment approach tends to cut through the centres of many bog systems.

creates boundaries that are almost the worst possible form of boundary in terms of peatland function. The extent to which catchments fail to provide adequate functional units can be seen by comparing the macrotope boundaries already indicated in Figure 1 with the catchment boundaries drawn up for the Lewis EIS (see Figure 2).

It is clear from Figure 2 that the preponderance of watershed, saddle and spur mires in the area means that a traditional river catchment approach is not appropriate to the task of defining such hydrological units. The identified catchment boundaries not surprisingly cut directly through the majority of mesotopes and thus provide no useful peatland boundaries.

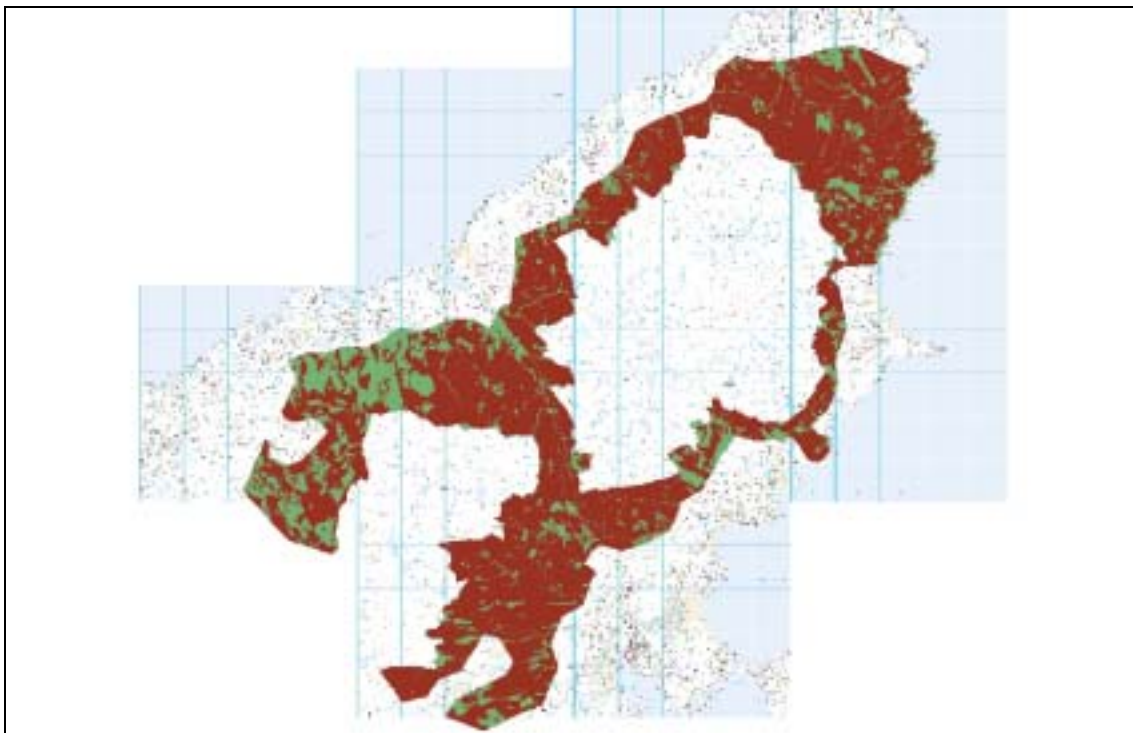
Figure 6. The distribution of 'active blanket bog' (shaded dark red) within the HSA area. Areas within the HSA that are not active bog are shaded mid-green. The definition of 'active bog' is based on all mapped NVC classes M1, M2, M3, M15, M17, M18, M19, M20, that lie within the Erosion Classes 1, 2, 3, 4, and 6. The OS 1:25,000 scale map is provided as background.

It is not possible to undertake a complete GIS re-analysis of the potential extent of 'active blanket bog' in the light of the various inconsistencies and possible errors described above. This is because part of the problem lies in the identification of NVC types directly in the field, so although a quantitative estimate can be arrived at on the basis of the sample quadrats provided, the specific location of altered NVC types cannot be determined without re-survey. Nonetheless, it is possible to re-do the GIS analysis discussed above but this time re-assigning Erosion Classes 4 and 6 to the 'active' category. The resulting map can be seen in Figure 6.

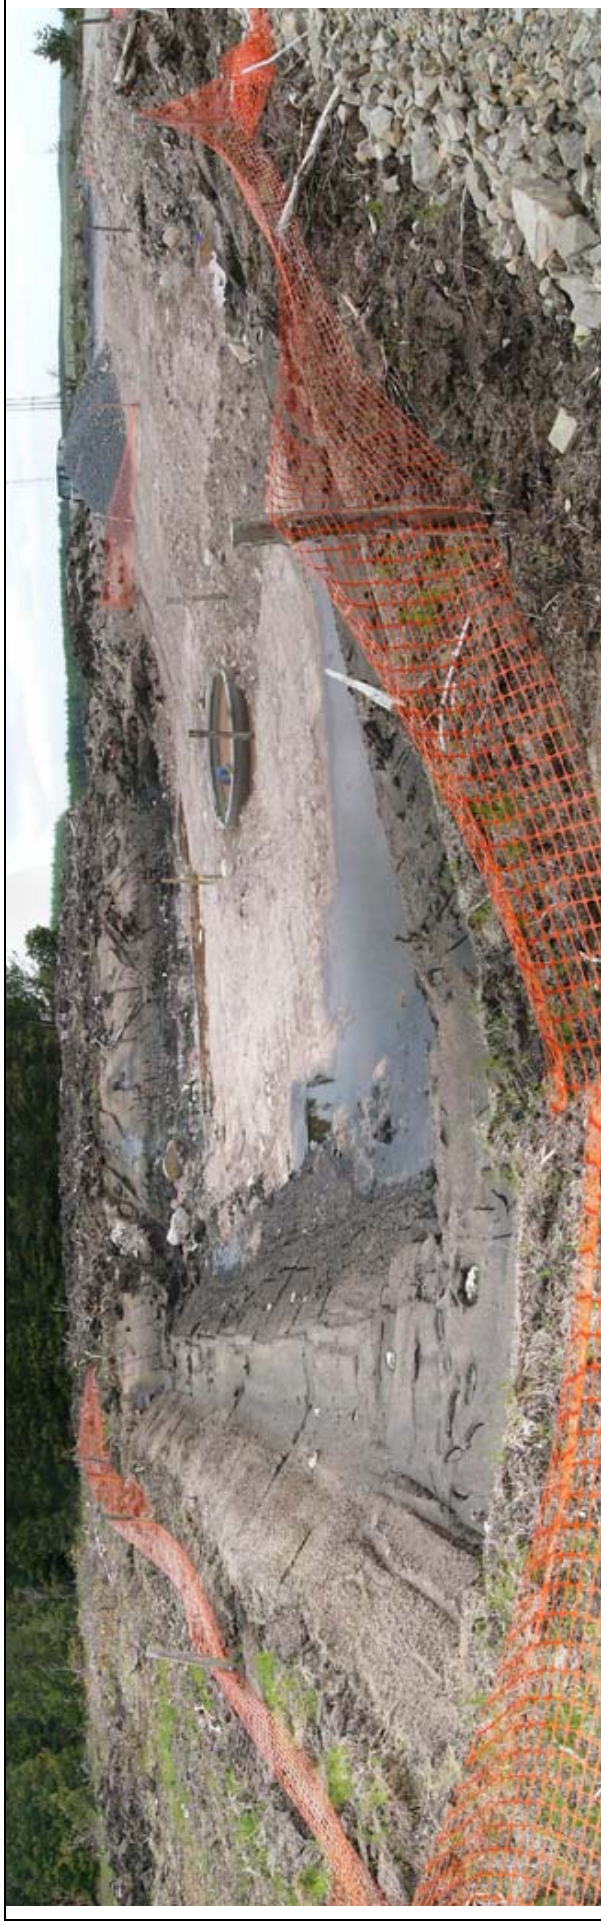
Figure 7. Panorama of turbine-base excavation at Derrybrien, Co. Galway, showing the extent of the excavation within the general blanket bog expanse. The turbine base, visible as the light green circle in the centre of the excavation bed, is approximately 4 metres in diameter. The dimensions of the excavation can thus be seen to be approximately 50 metres x 50 metres. The concrete base into which the base-can is set, is now buried beneath hardcore backfill, but is 15 metres x 15 metres. The size of base proposed for Lewis is significantly larger, at 22 metres x 22 metres.

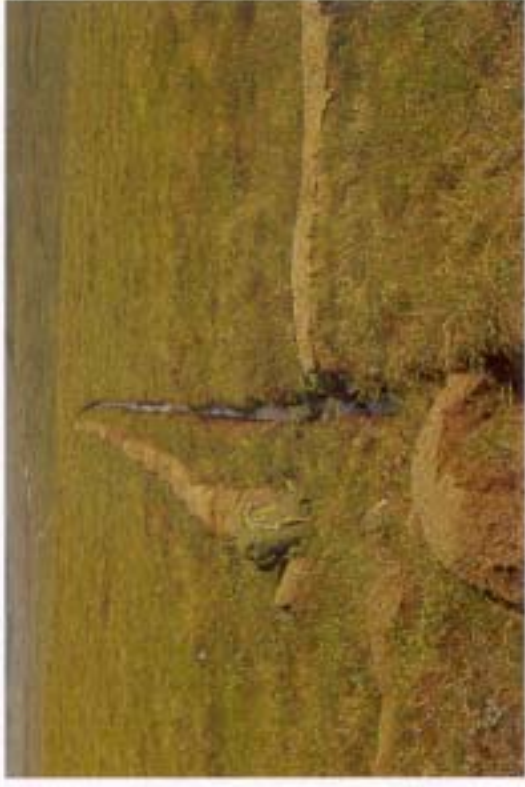
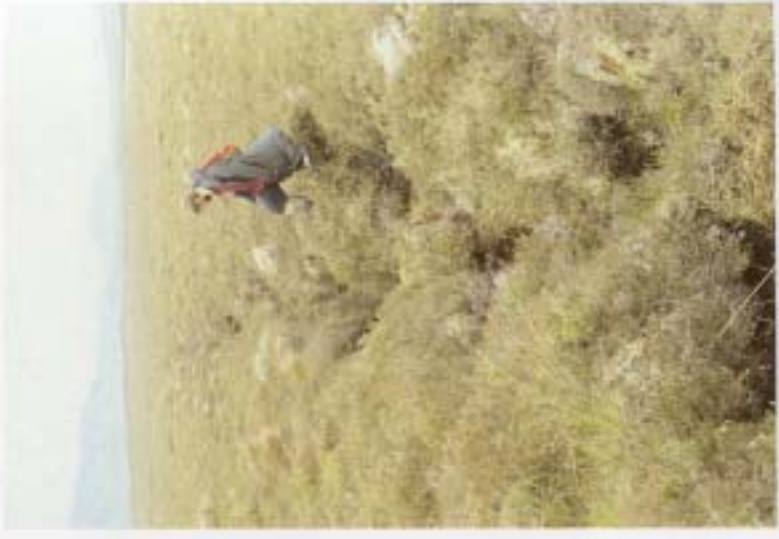
Figure 8. On the left is a ditch cut very recently into blanket peat. Even at this young stage, there are evident areas where the ditch sides have slumped. On the right is a ditch that has been established for a considerable number of years. The increased width of the ditch is evident amidst the slumped, collapsed and eroding vegetation. The relatively dry nature of the surrounding bog vegetation can also be seen in the repeated pale hummocks of *Racomitrium lanuginosum*. This vegetation is probably M17a or M18a of the image on the left. Both photographs were taken in Sutherland.

Meanwhile any areas of the catotelm directly exposed by the drainage process (ditch sides, *etc.*) will undergo drying and oxidation, leading to loss of peat material and consequent changes in the surface shape of the bog - in effect the sinking peat surface progressively widens the ditch. This means that the impact of the ditch is felt over a greater area of acrotelm, and so the system establishes a negative feedback loop that can be quite destructive to the surrounding bog vegetation. This process can be seen for a fresh ditch and an older ditch, both illustrated in Figure 8.

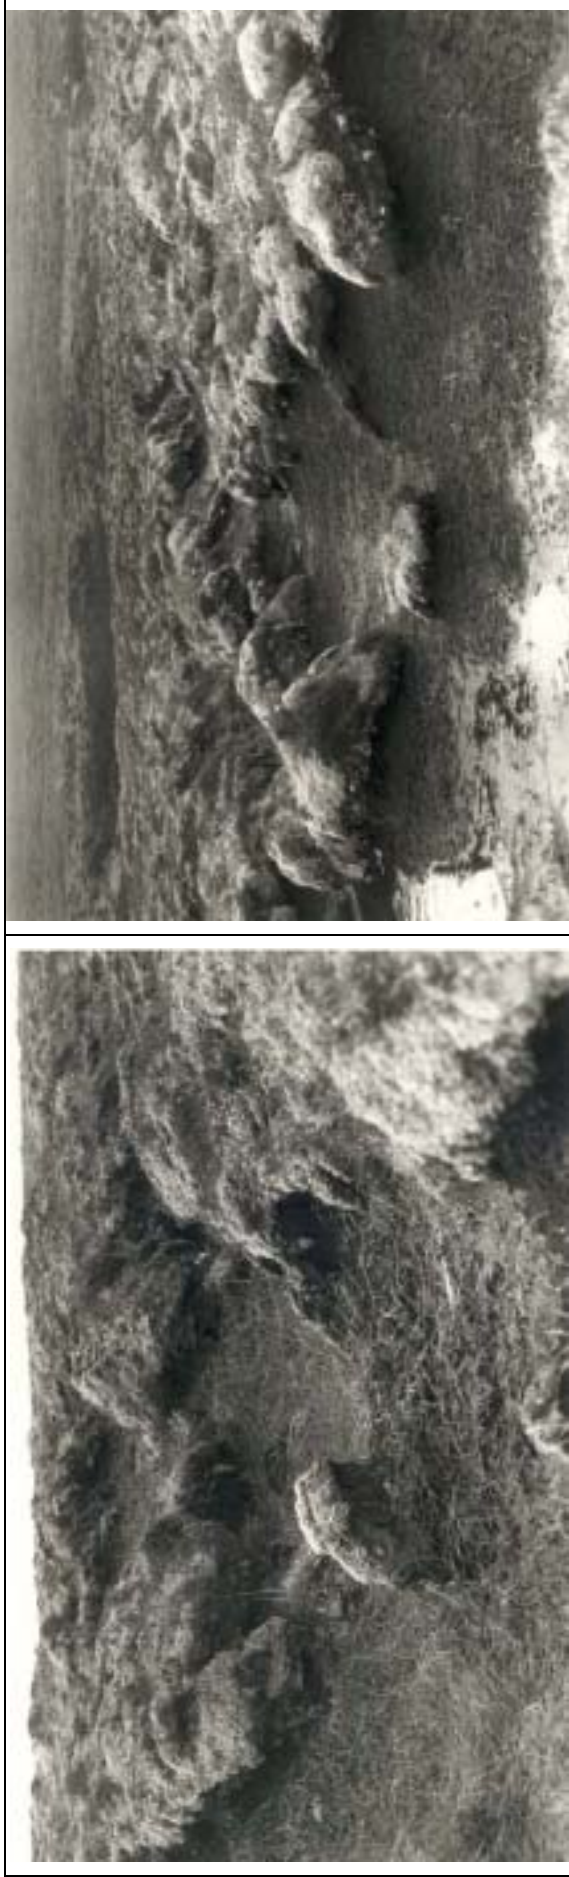
Figure 9. Two views of Blar nam Faoileag, Barvas Moor, photographed from the same location, one looking upslope and the other looking downslope. The effect of cutting a ditch from left-to-right across these photographs, as might occur if a road were constructed here, or of excavating a turbine base, can be imagined fairly readily; substantial deepening, by rejuvenation, of the erosion gullies is a strong possibility.

Figure 9 shows two views of an erosion complex at Blar nam Faioleag in the centre of Barvas Moor. It takes no great imagination to imagine the rejuvenating effect of cutting a ditch, or digging an excavation, across the line of these evident erosion gullies. A river is rejuvenated if the river bed or its outflow is lowered, steadily cutting back along its course and deepening the bed until it once more forms a graded profile. In the same way, initiation of erosion (as with Neolithic clearance of forests on the slopes below the blanket peat cover, described by Tallis 1995), or rejuvenation of an existing erosion complex (as described in the Lewis EIS Report), can result in a dramatically increased level of erosion, peat removal, and consequent habitat loss.

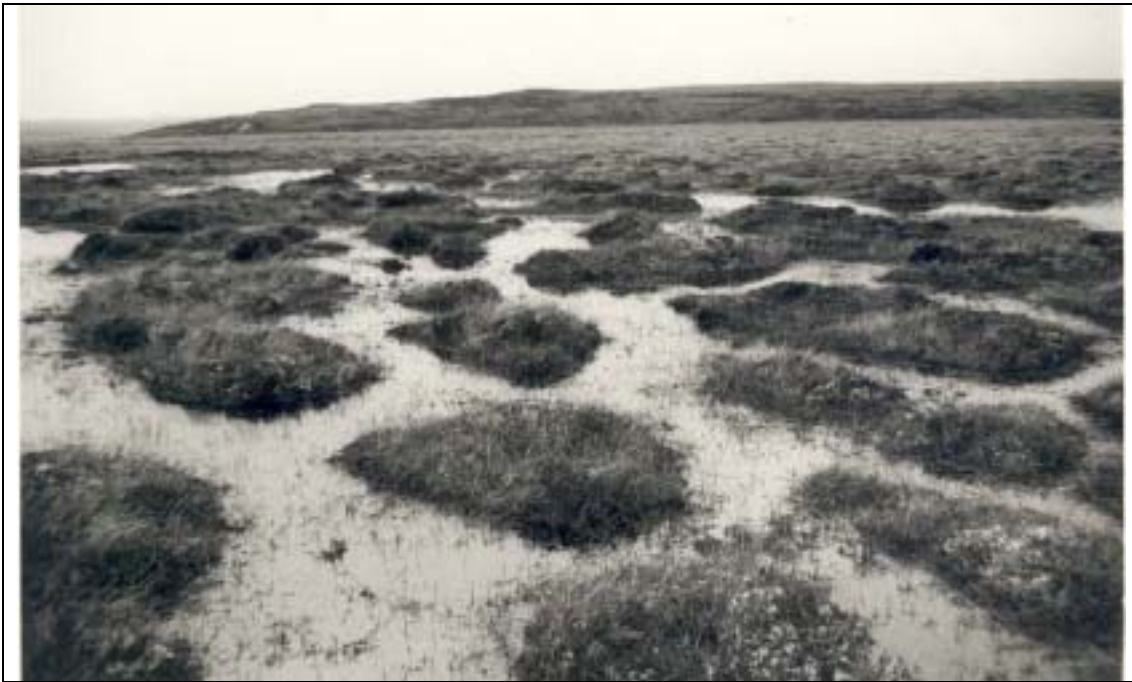
Figure 10. A relatively undisturbed valleyside mire from Barvas Moor, Lewis. Clearly the cutting of a ditch or digging of excavation within such an area is likely to lead to catastrophic de-watering of the pool system to form an erosion complex.

The effect of cutting a ditch or digging an excavation on an area that is not currently subject to erosion and which supports a relatively wet bog vegetation, is also likely to be dramatic. Figure 10 shows a typical example from Lewis of what the Lewis EIS Report describes as a ‘perched pool network’, but in usual terminology would be a straightforward valleyside mire. It should be fairly obvious that cutting into a system such as this would lead to sudden and serious erosion of the pool system.

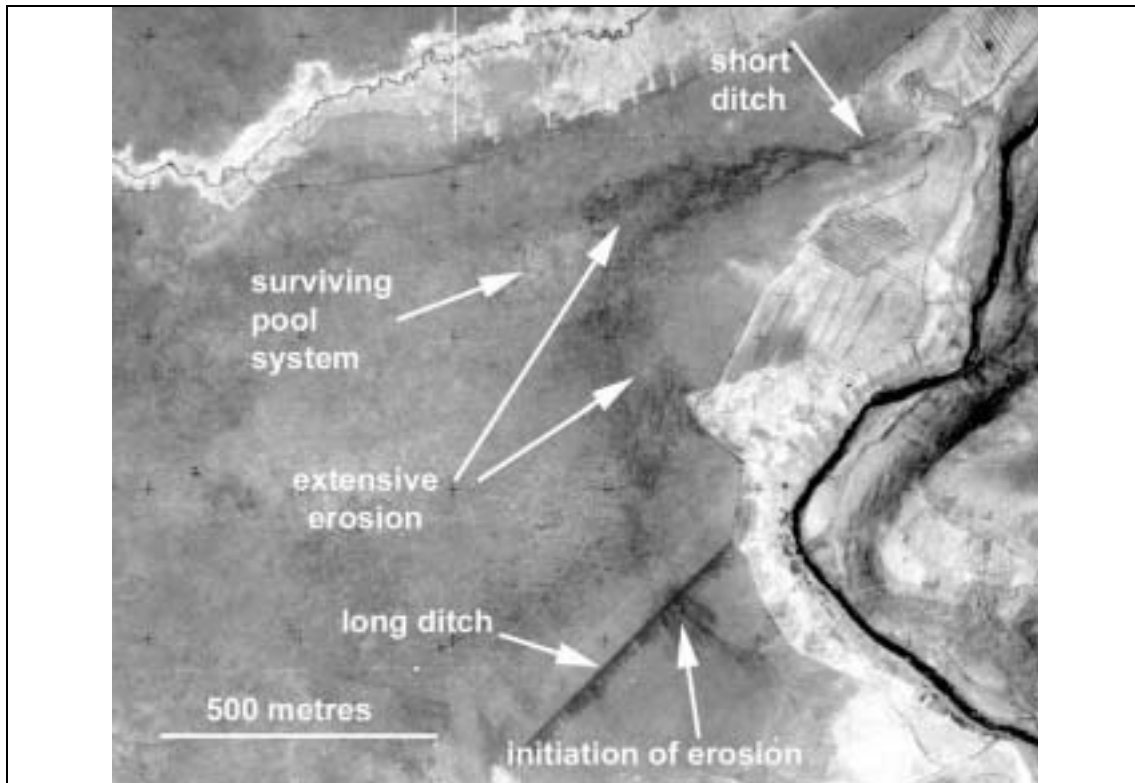
Figure 11. Vertical aerial photograph of Butterburn Flow, Cumbria (north is at the top of the photo). This is an area of blanket bog that originally possessed a natural low-ridge/hollow microtope across the gentle dome of the mesotope. A short ditch cut into the western side of the mesotope has led to extensive erosion through the microtope pattern. Similarly, a ditch cut along the south-eastern margin of the mesotope has also initiated erosion.

Figure 11 shows a vertical aerial photograph of Butterburn Flow, a blanket bog site in the north Pennines. Two ditches can be seen to have been dug into the site, one on the very right-hand margin of the main bog mesotope, the

other cutting across the lower slopes of the mesotope that lies to the north (to the top of the photo) of that drain. The main bog mesotope comprises a watershed/valleyside mire, forming a broad expanse of peat across a low hill, and the crown of the bog supports (or supported) a microtope consisting of low ridges and small hollows.

Clearly, from Figure 11 it can be seen that not only is initiation of erosion by drainage possible, but that this erosion may extend for very considerable distances. In the case of Butterburn Flow, the erosion complex initiated from one small ditch has extended over an area that stretches for almost 1 km. In effect, if a mesotope supports a microtope pattern, and drainage then disrupts this microtope, the breakdown of this microtope pattern is likely to spread across the whole area of the pattern, and may lead to breakdown of other adjacent microtope patterns within the same mesotope.

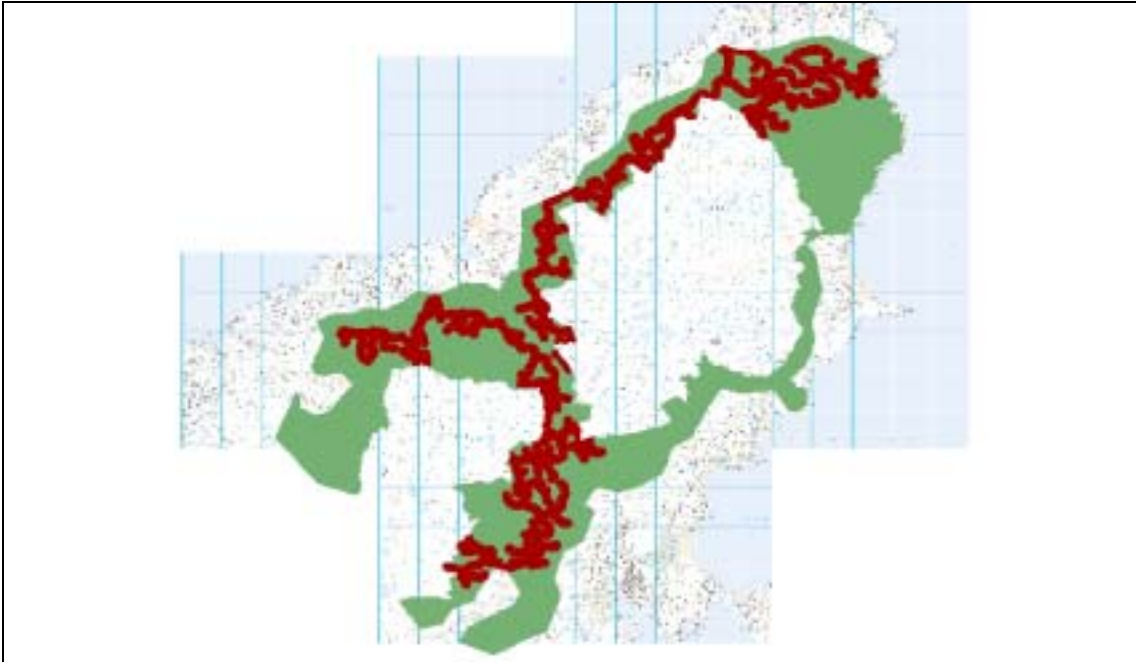
Figure 12. Map showing total HSA area (mid-green) and area of roads and turbines, with a buffer of 250 metres radius around both these features. The OS 1:25,000 scale map is provided as background. (OS map © Crown Copyright : All rights reserved. RSPB Licence No. 100026659)

An assessment can then be made of the road and turbine network in relation, initially, just to the area of the peatland habitat within the SPA that might potentially be affected. The area of 'active blanket bog' (as defined in Figure 6) that may be affected by wind farm construction and the farm's ongoing presence can then be calculated. The results can be seen in Figures 12 and 13 and Table 3.

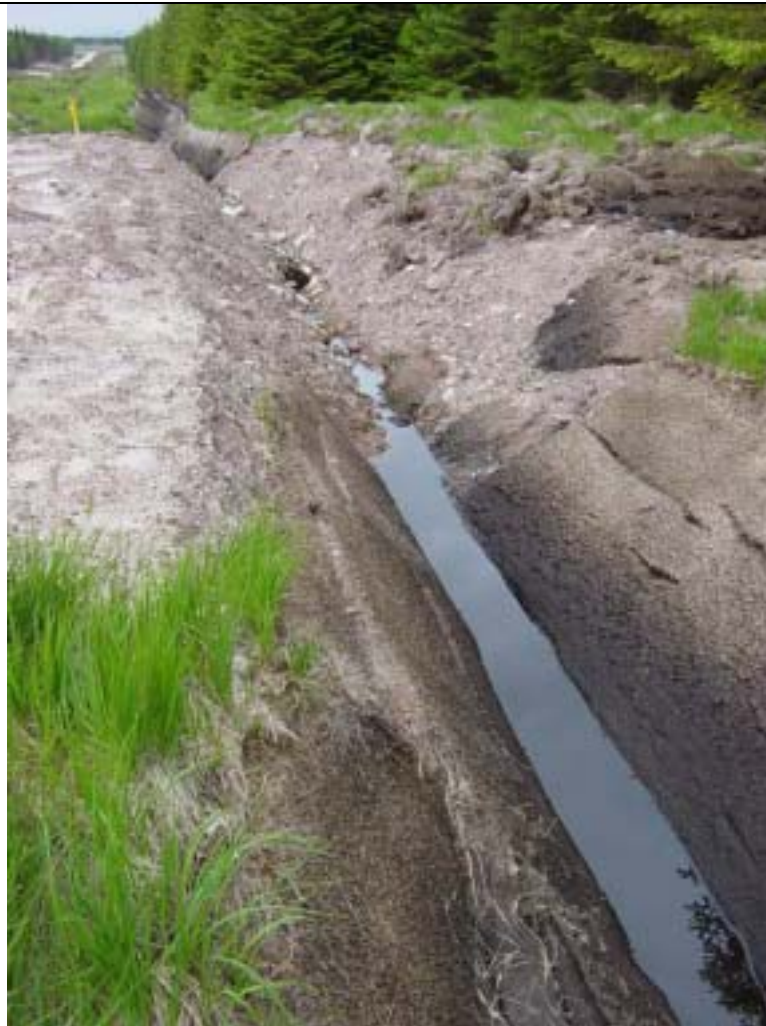
Figure 14. Drain installed after construction of the floating road visible on the left of the photograph. The road was constructed as part of a wind farm development at Derrybrien, Co. Galway, where the original proposal was for all roads to be undrained and floating on peat.

Having installed drains alongside the floating road network, the effect of the floating roads is just like any other sort of drainage or peat cutting, in terms of its potential to cause vegetation change and initiate erosion. All the problems and impacts summarised by the Lewis EIS Report concerning peat cutting applies equally to such drainage.

However, as the drainage system must be maintained if the drains are to work effectively, the process of catotelm loss through oxidation of the peat becomes a long-term feature of the drains along the roadway. This loss of catotelm material causes the road gradually to sink into the peat, thereby causing greater problems of ponding, and thus requiring even more drainage. This cycle of shrinkage and drainage becomes a negative feedback process, making road maintenance increasingly difficult but also causing the drains to have an increasingly wide influence over the surrounding acrotelm.

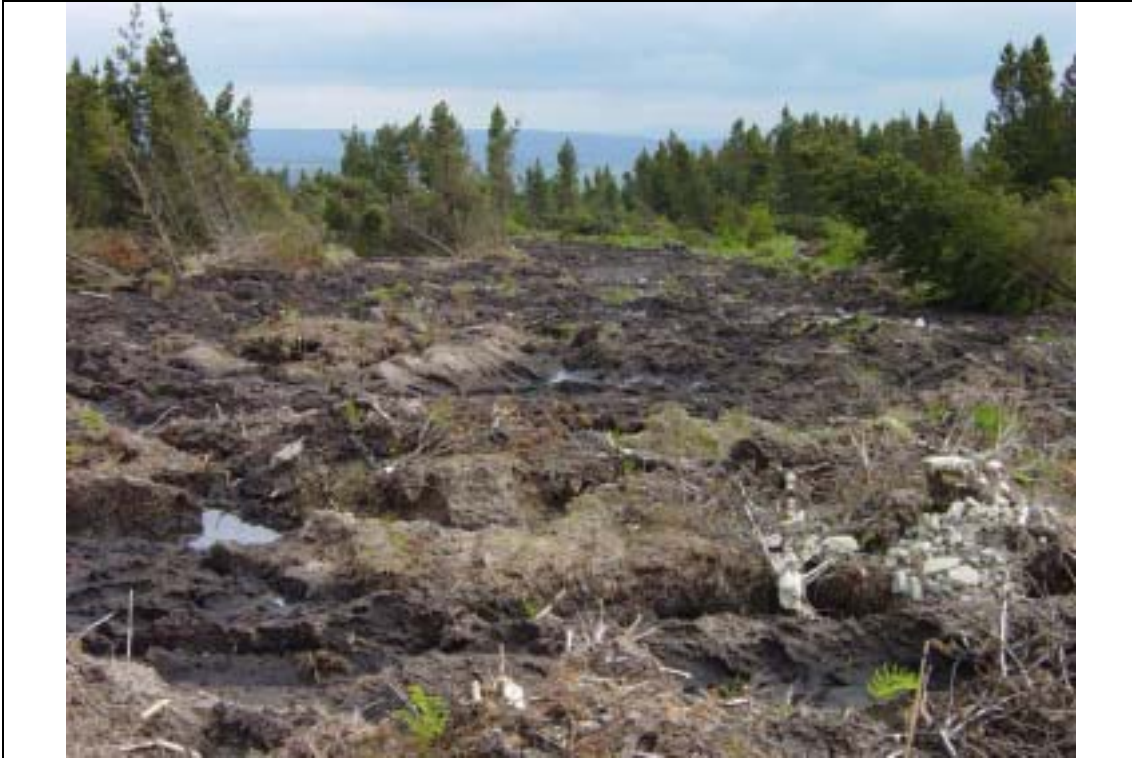
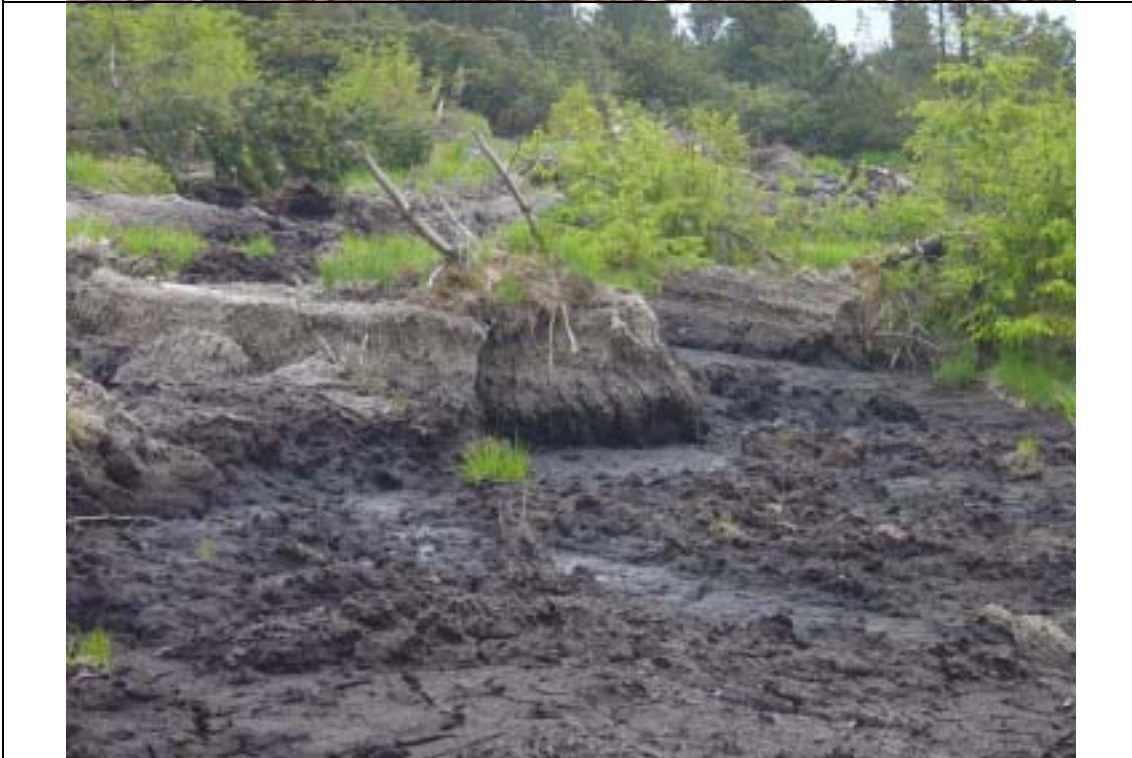
Figure 15. The upper reaches of the bog slide at the Derrybrien Wind Farm, Co. Galway. Approximately 1.5 km of peat slid down the hillside before entering a river system and flowing 20 km into a large local fishing lake, where some 50% of all fish were killed.

Several aspects of the windfarm construction on Lewis could act as triggers of instability, pre-disposing areas to undergo failure and cause a bog slide. However, the most obvious potential cause of such instability is the intention to use rock-fill on the least stable peats. It is generally considered by engineers who have examined the causes of the Derrybrien bog slide that it was initiated by bearing failure as large quantities of peat were piled onto the peat surface adjoining the excavation of the turbine base. Pouring large rocks

onto an unstable peat surface is a process very similar to that which may have caused the Derrybrien bog slide. One must question the wisdom of such a proposal.

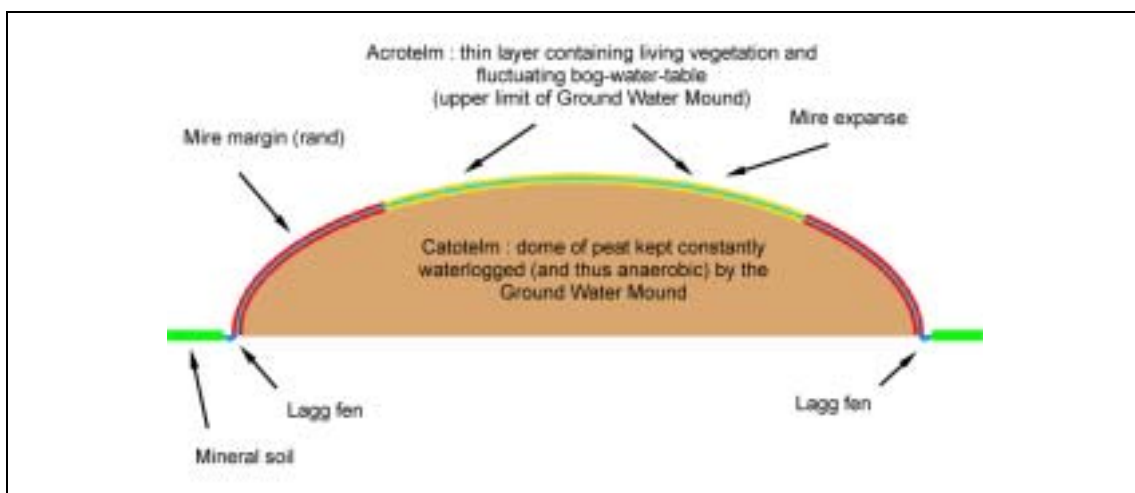
Figure A1. Raised bog system showing the relationship between the main dome of rain-fed peat (the bog mesotope) and the minerotrophic fen (lagg fen) formed at the contact zone between bog peat and the mineral ground. The shape of the dome is formed by the mound of water contained within the peat. The thin acrotelm layer contains the fluctuating bog water table (blue line), and consists of two broad zones - a zone of steep hydrological gradient at the margins which is dominated by red-coloured hummock-forming *Sphagnum* species, and the central zone of lower hydrological gradient which is dominated by low ridges and hollows formed by yellow-coloured *Sphagnum* species. The whole system is a macrotope consisting of

two inter-connected mesotopes.

Figure A1 shows the essential structures of the mesotope and the macrotope for a raised bog. The ombrotrophic (bog) mesotope consists of the thin acrotelm layer covering the deeper catotelm peat, all given shape by the mound of water contained within the peat matrix. The minerotrophic lagg fen mesotope around the margin of the bog consists of a waterlogged zone derived partly from the mineral ground-water table and partly from run-off from the bog. The whole assemblage of bog and fen forms the macrotope.

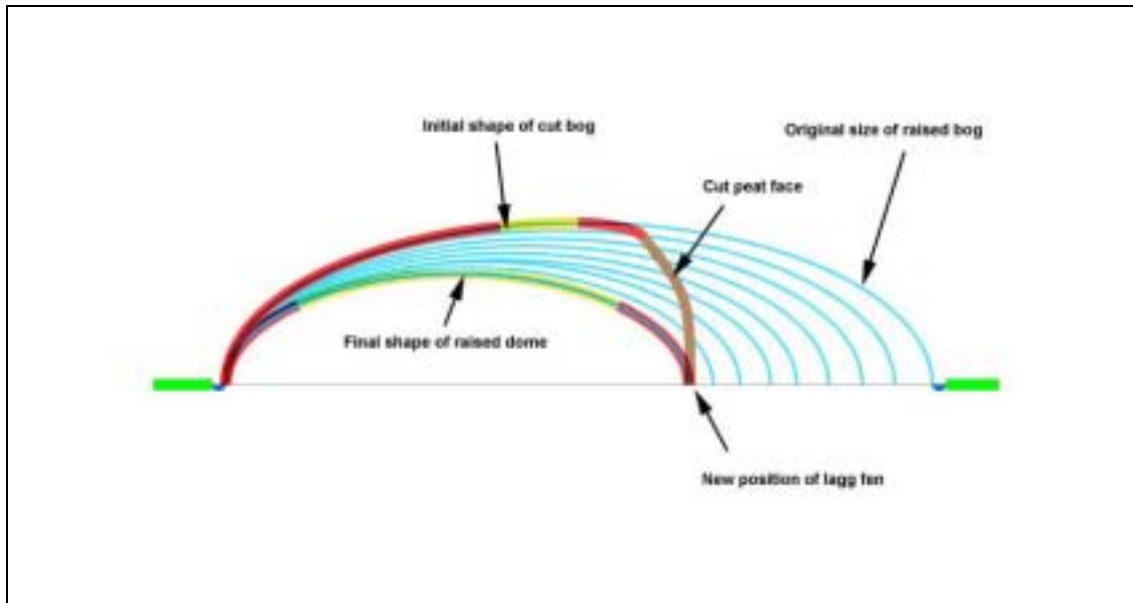
Figure A2. Effect of removing part of a raised bog. The process of morphological and vegetation change, as the bog settles to a new stable shape, can be seen in the change from the blue shape of the original groundwater mound, through the disrupted cut shape and ultimately to the new stable groundwater mound based on the new diameter of the bog. The pattern of small-scale surface features and vegetation has changed, as has the position of the lagg fen mesotope.

This is one of the important consequences of the Ground Water Mound Theory for bogs - remove part of the bog and over a period of time the bog will sink to a new stable shape, just as a droplet of water would. This sequence of change can be seen in Figure A2. Also apparent from Figure A2 is the impact on the pattern of small-scale surface features in the acrotelm, with a significant decrease in the extent of low ridges and hollows and so the effects of peat removal have an impact at all levels of the eco-hydromorphological hierarchy. An impact at one margin of the bog system ultimately has an effect across the whole bog macrotope, because not only has the bog mesotope changed shape, but the fen mesotope has also changed location and total extent.

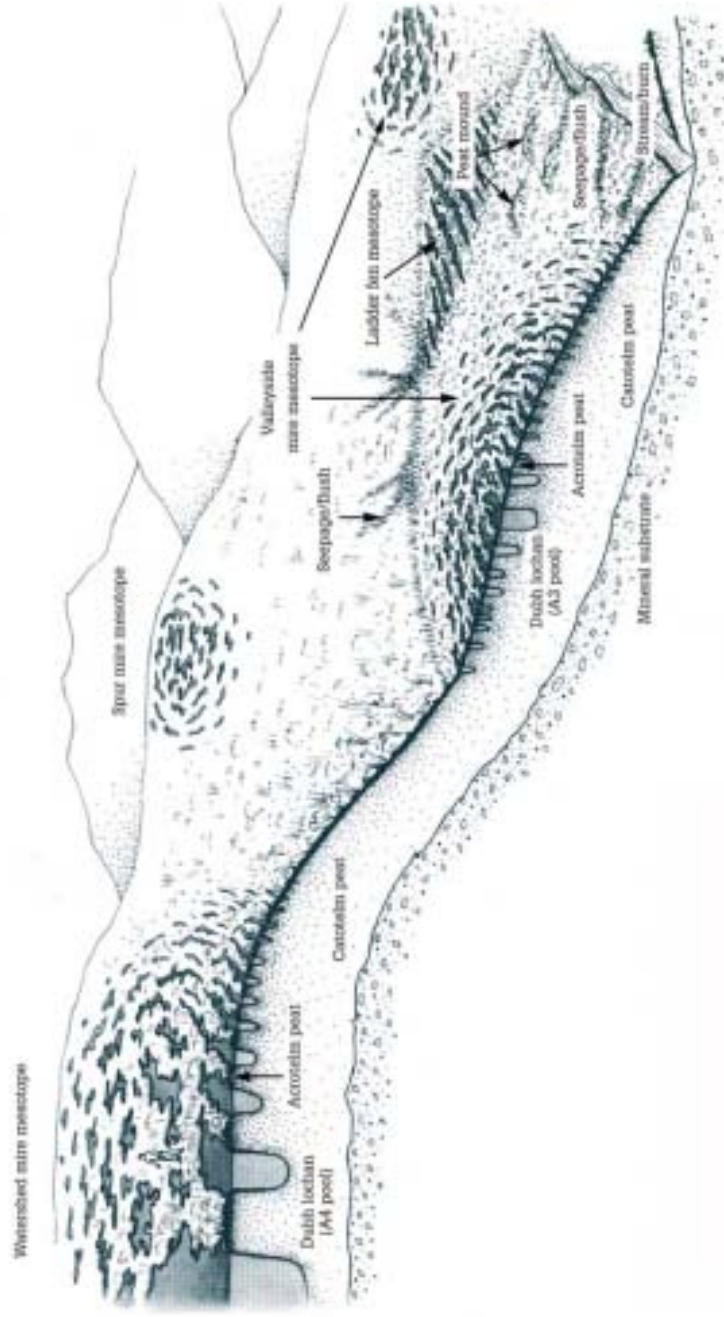
Figure A3. Schematic representation of blanket mire, adapted from Lindsay *et al.* (1988), showing the relationship between peat depth and slope of the underlying mineral substrate, as well as the physical (and associated hydrological) inter-relationships between the various structural components of a blanket bog complex [or macrotope]. (Depth of peat exaggerated compared to horizontal scale).

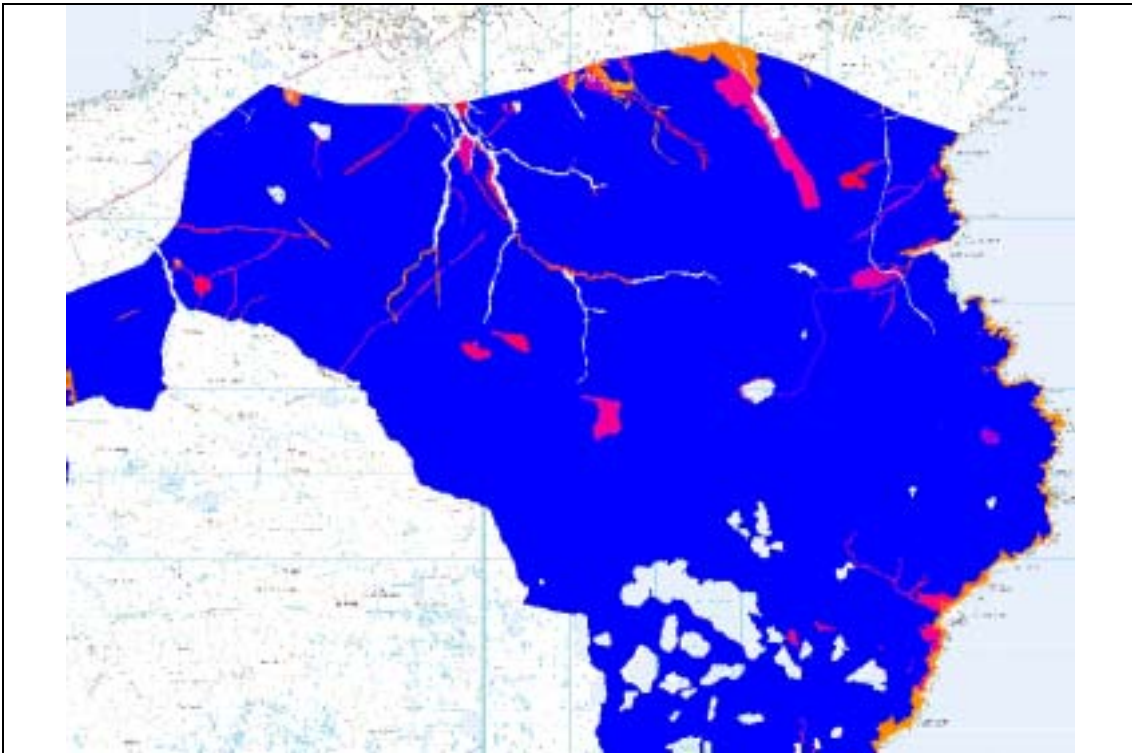
Figure 8(a & b). Map of wind farm roads and peat thickness. Blue represents peat with a thickness of more than 1 metre. The colour gradient runs from blue to purple to red to orange, with orange representing peat that is less than 10 cm thick. The OS 1:25,000 scale map is provided as background.

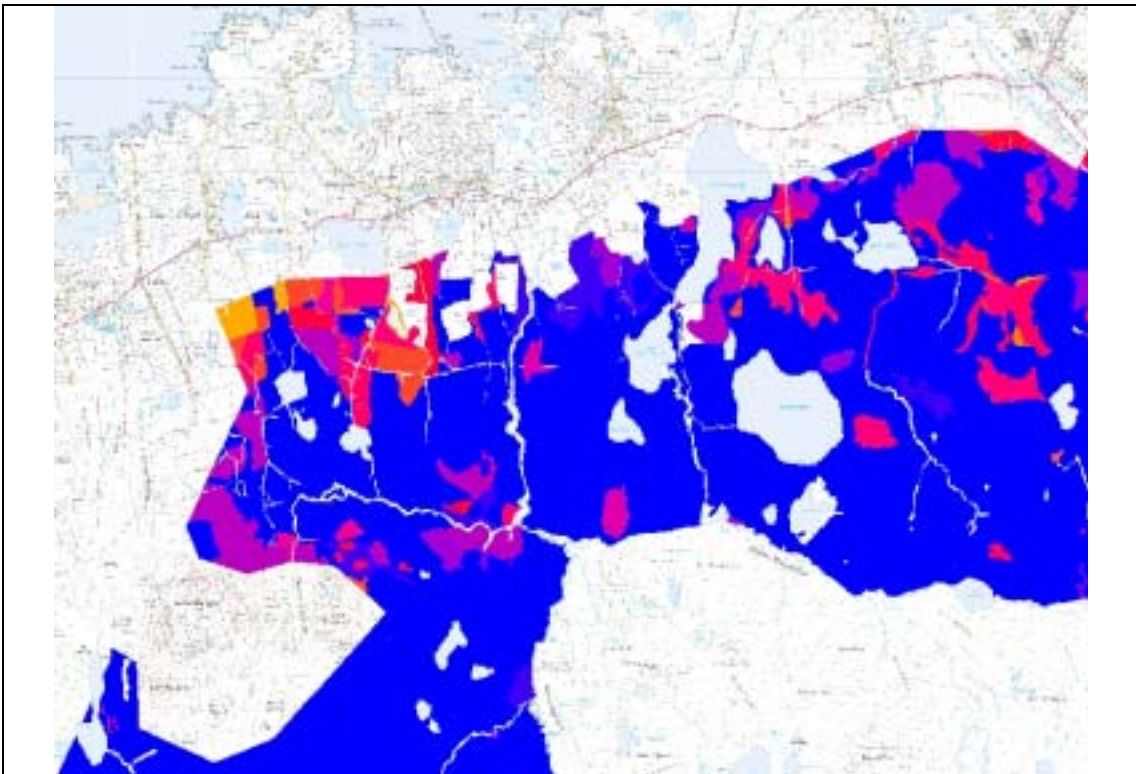
Figure 8(c&d). Wind farm roads and peat thickness. Colours as described above. The OS 1:25,000 scale map is provided as background.

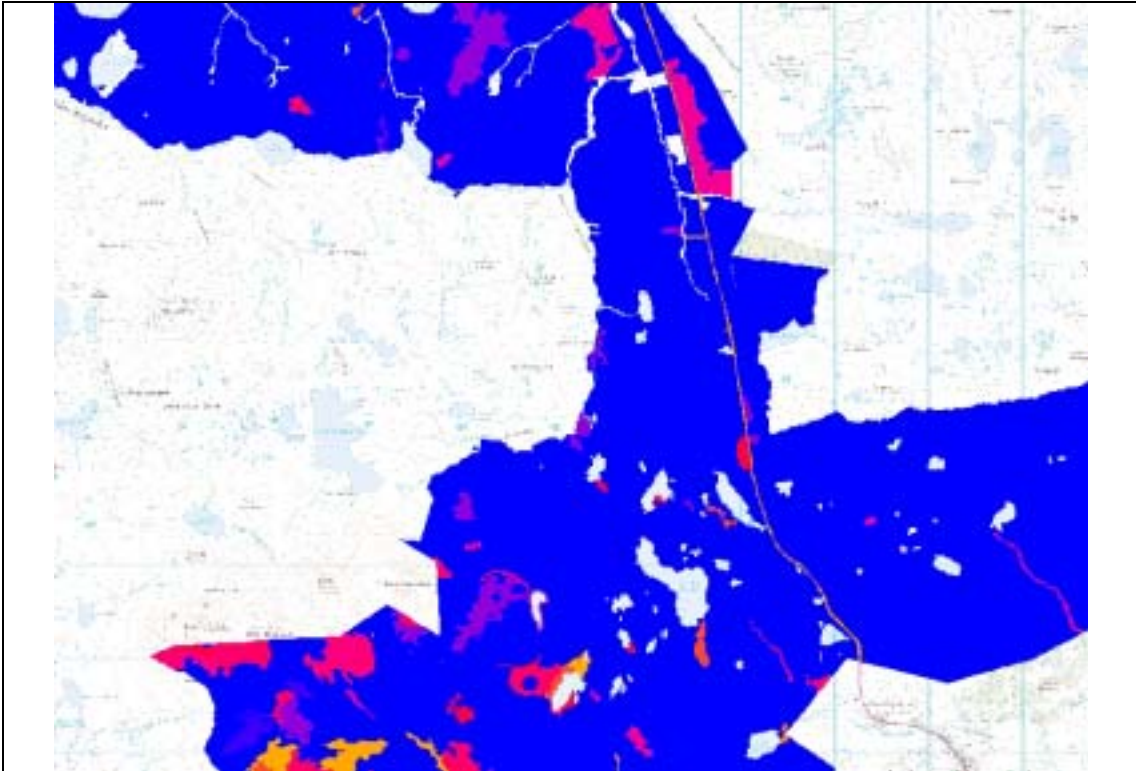
Figure 8(e & f). Wind farm roads and peat thickness. Colour codes as described above. The OS 1:25,000 scale map is provided as background.
